Windstorm Mitigation Report

Laurelwood Condominium I

Clearwater, FL

As of 06-19-2024 | FPAT File# MUD2422807

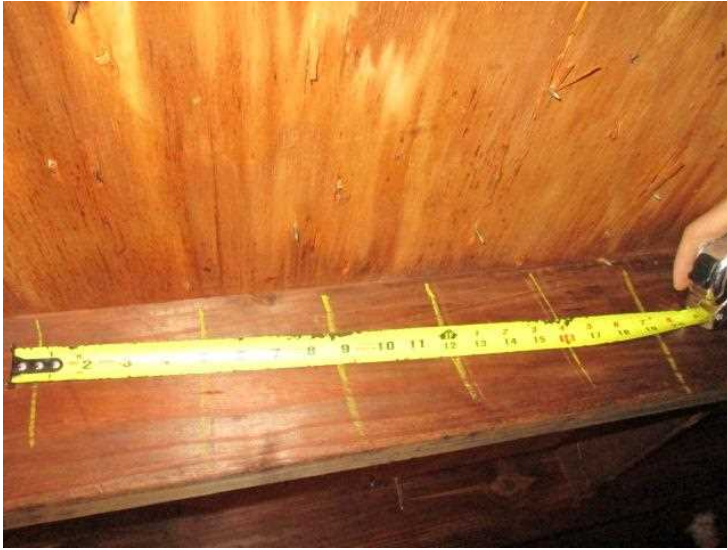
Roof Construction

Comments: | FBC Equivalent
The roof coverings were replaced in 2013. The roof permit was confirmed and the permit number is BCP2013-03289. This roof was verified as meeting the building code requirements outlined on the mitigation affidavit. |

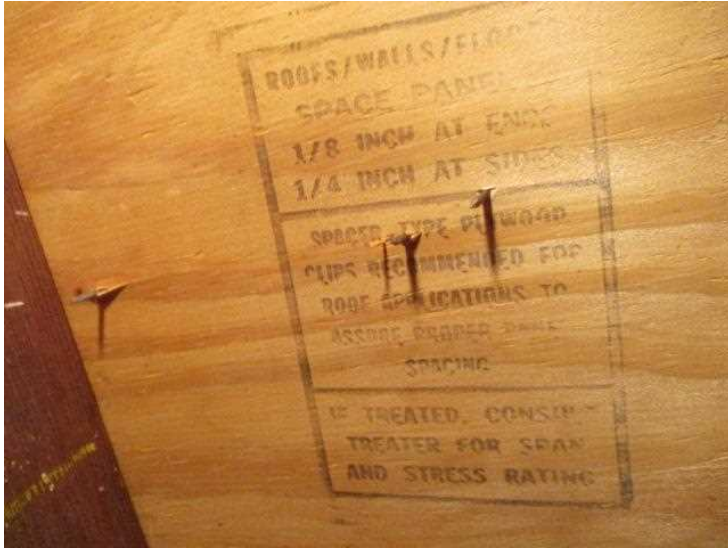
Roof Construction

Comments: | FBC Equivalent
The roof coverings were replaced in 2013. The roof permit was confirmed and the permit number is BCP2013-03378. This roof was verified as meeting the building code requirements outlined on the mitigation affidavit. |

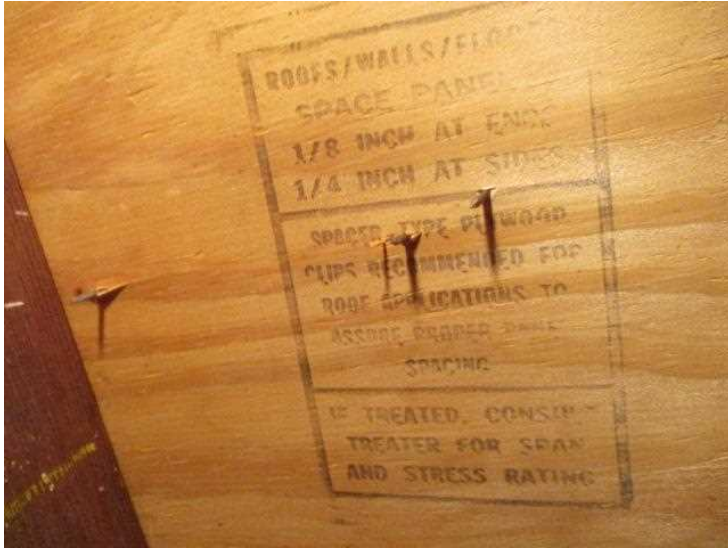
Roof Construction

Comments: | FBC Equivalent
The roof coverings were replaced in 2013. The roof permit was confirmed and the permit number is BCP2013-03374. This roof was verified as meeting the building code requirements outlined on the mitigation affidavit. |

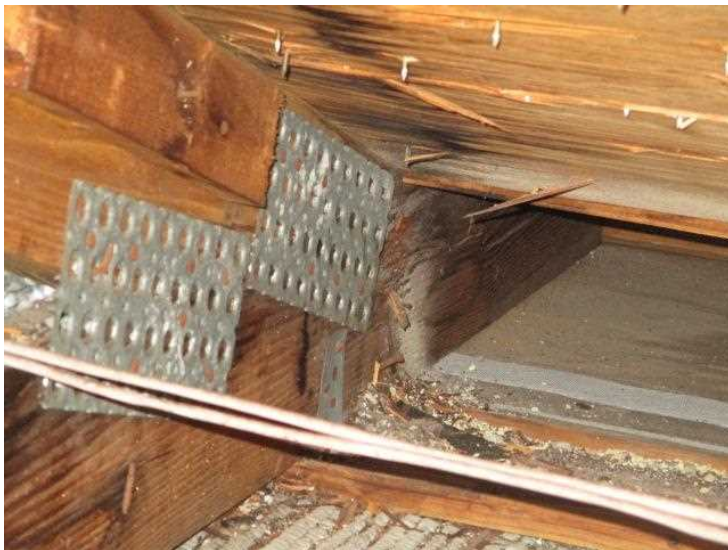
Roof Construction

Comments: | FBC Equivalent
The roof coverings were replaced in 2013. The roof permit was confirmed and the permit number is BCP2013-03377. This roof was verified as meeting the building code requirements outlined on the mitigation affidavit. |

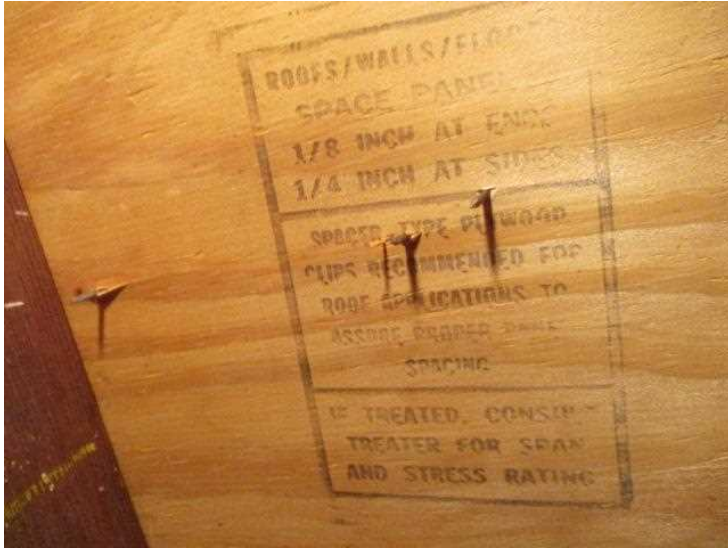
Roof Construction

Comments: | FBC Equivalent
The roof coverings were replaced in 2013. The roof permit was confirmed and the permit number is BCP2013-03375. This roof was verified as meeting the building code requirements outlined on the mitigation affidavit. |

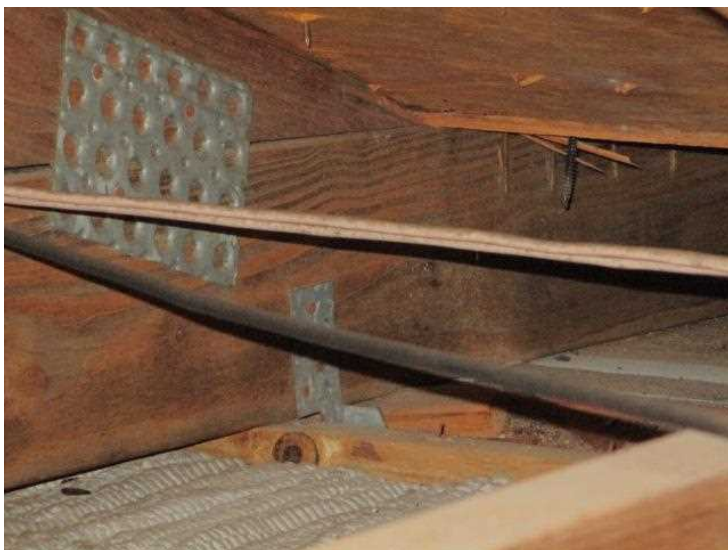
Roof Construction

Comments: | FBC Equivalent
The roof coverings were replaced in 2013. The roof permit was confirmed and the permit number is BCP2013-02379. This roof was verified as meeting the building code requirements outlined on the mitigation affidavit. |
